Workshop: Ultrasonic Imaging of Concrete Oakland, CA September 12, 2008

# Internal Imaging of Concrete Using Impact Echo Scanning

Patrick K. Miller, Project Engineer Yajai Tinkey, Ph.D., P.E. Larry D. Olson, P.E. Olson Engineering, Inc.

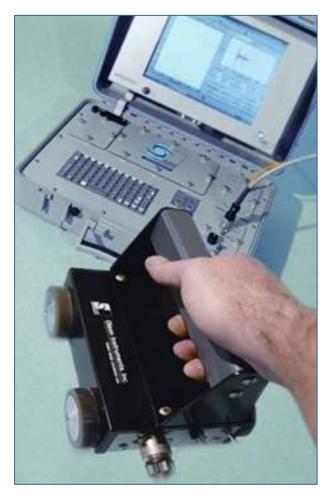
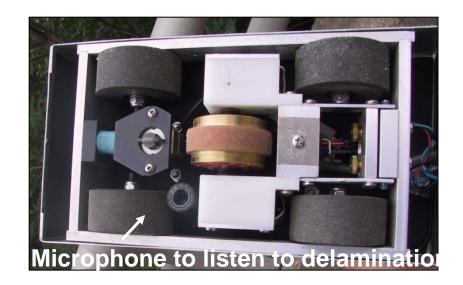
## **Olson Instruments IES System**

Impact Echo Scanner with rolling displacement Transducer and non-contact microphone

Olson Instruments Freedom Data PC and IES-1 system

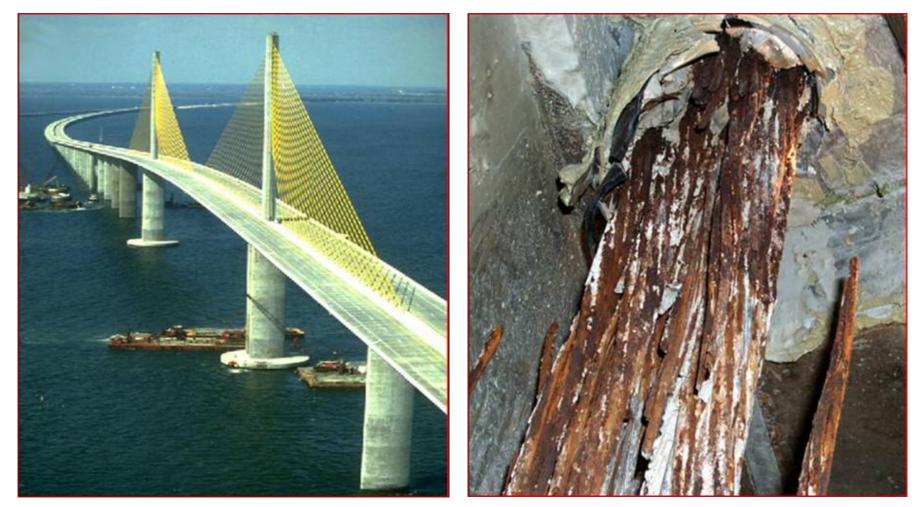
#### 2<sup>nd</sup> Case History - Void Detection in Post-tensioned Bridge Ducts

#### **Courtesy of Florida Department of Transportation**

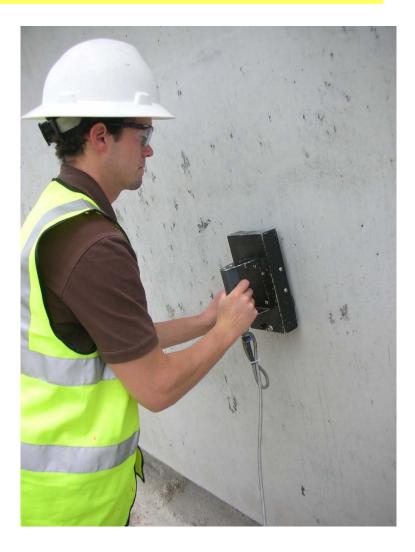
#### 3<sup>rd</sup> Case History: Detection of Internal Voids between PT-Ducts on Concrete Box Girder

- Precast concrete box girder with four 3" diameter PT ducts in each web.
- PT ducts empty at the time of testing, concern is for voiding between ducts due to poor vibration during placement.
- Web wall 7.5" thick, approximately 6' tall.
- Scans performed vertically at 1 foot intervals.
